## Pipe Conveyor Gallery- Tata Steel

Design specification and application of high performance suitable coating system for pipe conveyor gallery at Tata Steel Unit Jamshedpur .

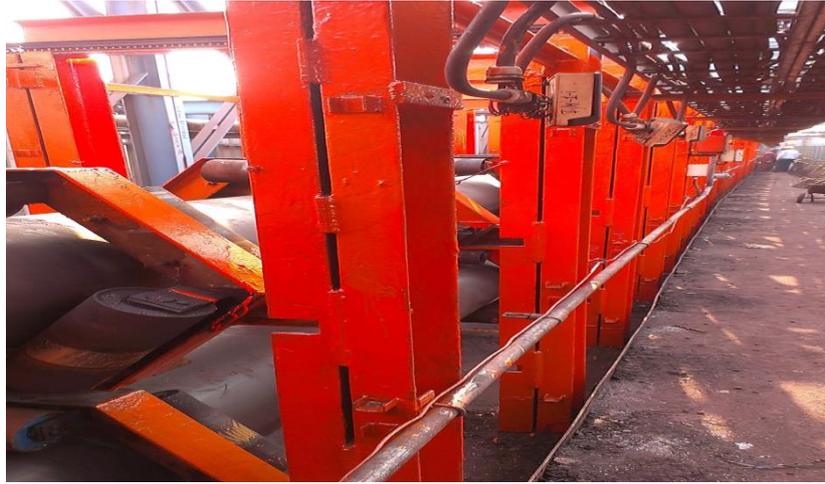
The pipe conveyor structures were highly corroded and pitted due to limited performance of existing coating system . The conveyor gallery was surrounded of number of cooling towers, ammonia plant , battery unit and was exposed to coke dust . the combinations of these factors had direct impact on corrosion rate and degradation of existing coatings systems.

The prevailing challenges and client expectation led to selection of Armaflake EHB with a DFT of 350-400 microns. The product has strong capability to bond with steel substrate even if marginally prepared and provide excellent resistance against saline environment and aggressive chemical environment.

The product was applied on power tool cleaned surface by a trained coating crew. Low pressure water jetting was also used prior to power tooling.

Armaflake EHB has demonstrated excellent results and is completely intact after 04 years. Coating evaluation was carried out as per ASM D 610 and was found in order. Based on current performance, the system may survive for couple of years and may or may not require very minor touch-ups.
